## Initial House Assessments & Sealing Efforts:

*California Builder #1*

Aerosol Sealing Installation Phase I: California Builder #1

**November 2017**

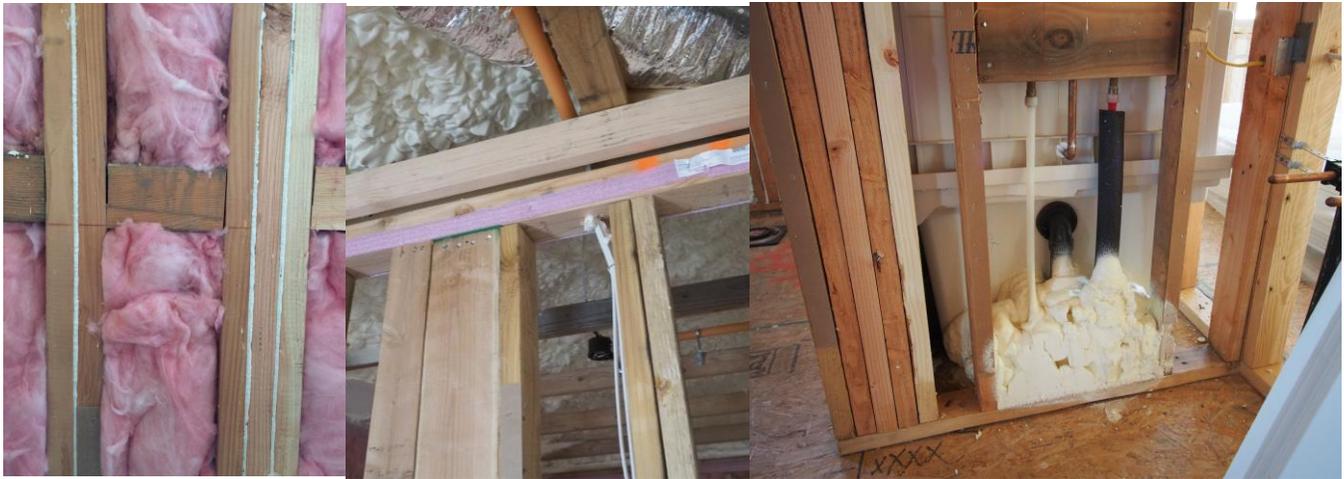
Figure 1. Air sealing details

Can foam used between double studs      Foam gasket to seal drywall between house and attic      Spray foam used at plumbing penetrations

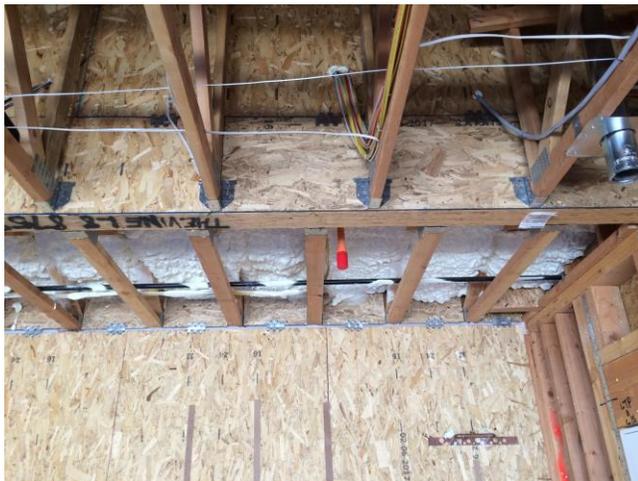
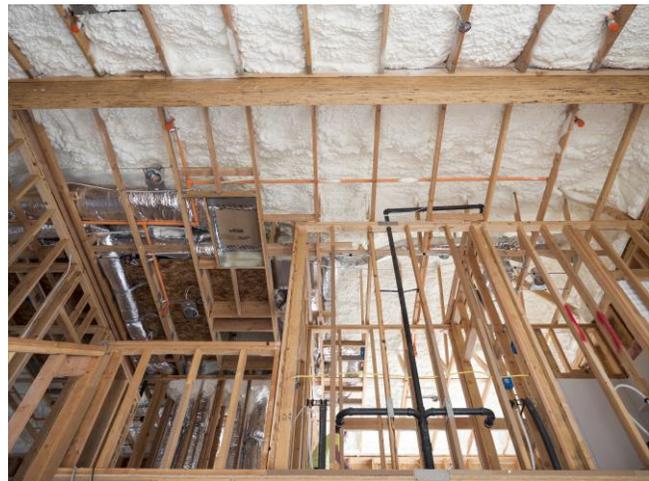
Open-cell spray foam installed at rim joist  
Figure 3. Photos of homes sealed under Option 1

Open-cell spray foam installed below roof deck

AeroBarrier sealing for Option 1 occurred after open-cell spray foam was installed at the rim joist and below the roof deck (Figure 3). No additional sealing was performed prior to the AeroBarrier installation. The pre-sealing results showed air leakage of 4.39 and 3.47 ACH50 for the two homes during this stage of construction.

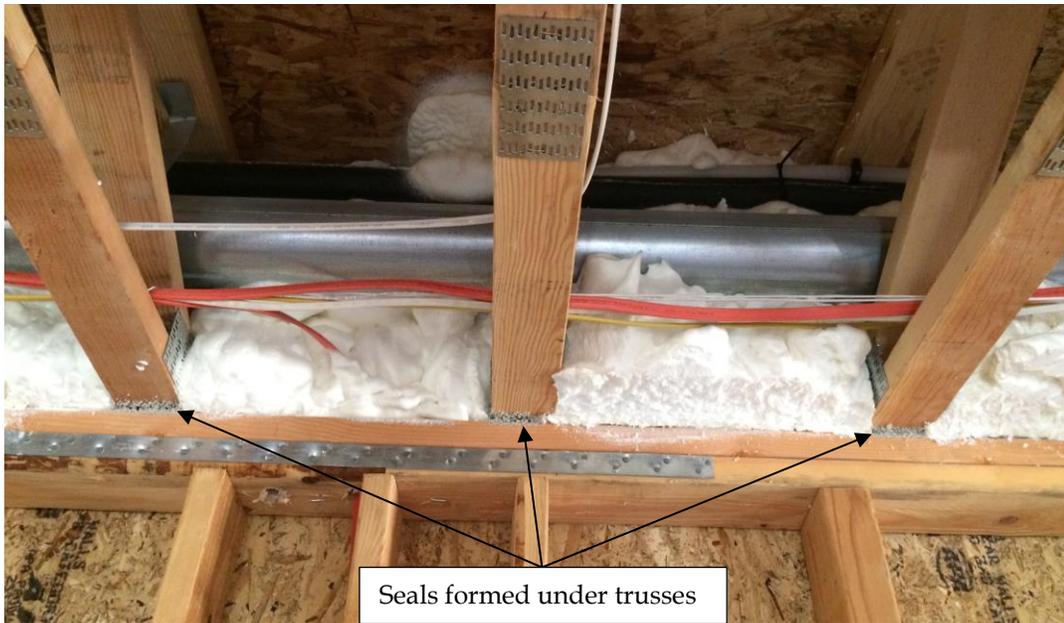
Figure 5. Photo of seals formed below each truss on first floor

While the open-cell spray foam sealed a significant amount of air leakage, the AeroBarrier still found locations that the foam did not seal. Figure 5 and 6 show photos of some of the locations that AeroBarrier seals were found. Many of these locations were between wood studs that were too small for the spray foam insulation. These were also not standard locations for installing can foam.

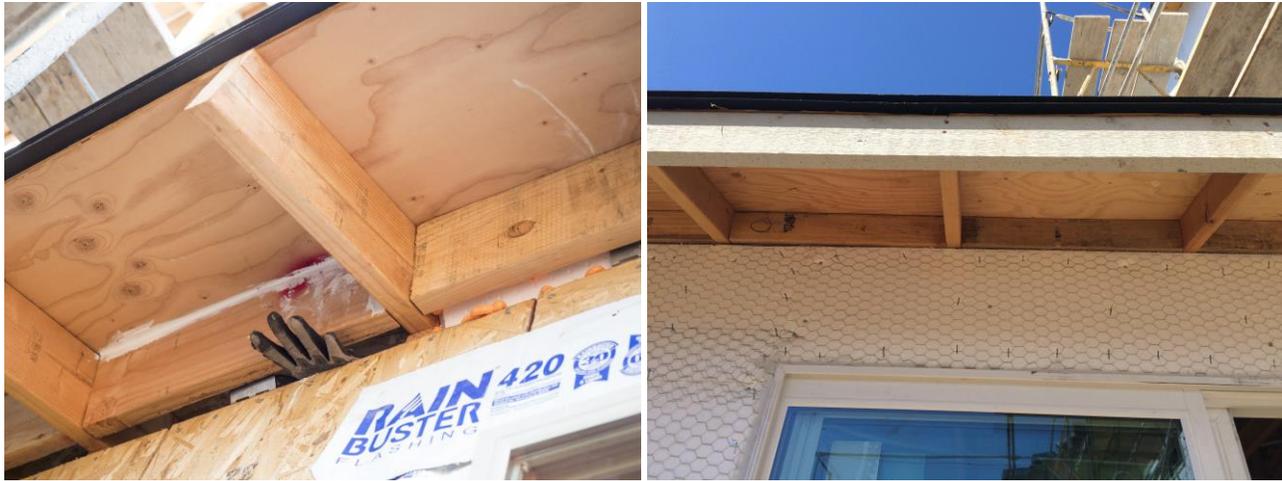
Figure 7. Gap at eaves requiring manual blocking prior to AeroBarrier (left), example of exterior ridged foam used to close the gap prior to open-cell spray foam installation (right)

AeroBarrier sealing for Option 2 occurred before open-cell spray foam was installed and represents the first opportunity to seal the homes since the building shell is largely complete. Some manual sealing prior to installing AeroBarrier was required to block larger penetrations that would not be sealed efficiently with the aerosol. The time and materials required to perform that sealing were documented. There were also some issues coordinating the sealing demonstrations with the home builder which led to some additional gaps at the eaves of the home that would normally have been blocked prior to the AeroBarrier installation (Figure 7 and 8).

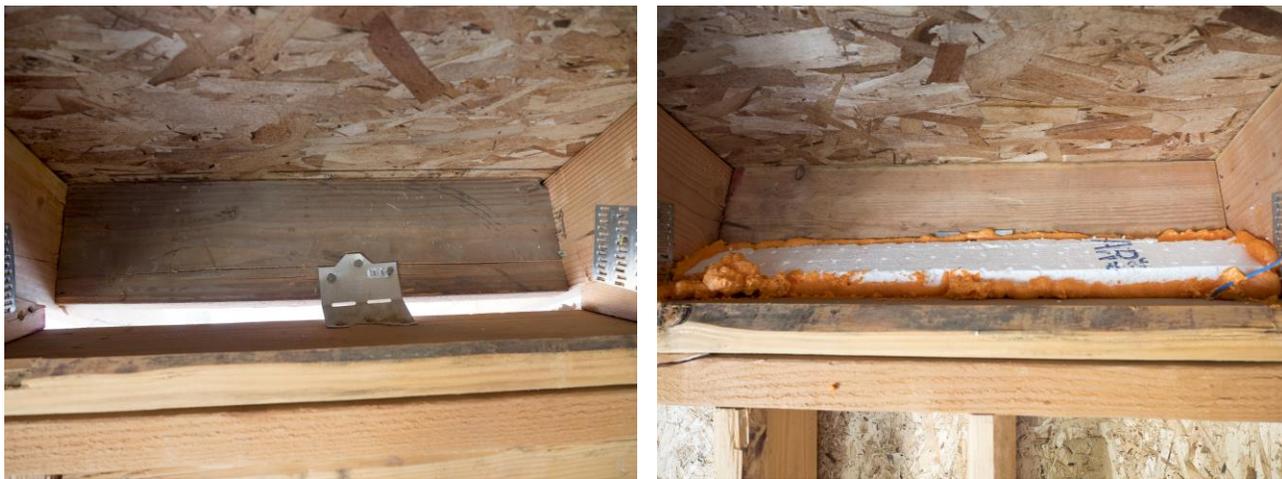
Figure 8. Gap at eave prior to sealing (left) and after sealing with ridged foam and can foam (right)

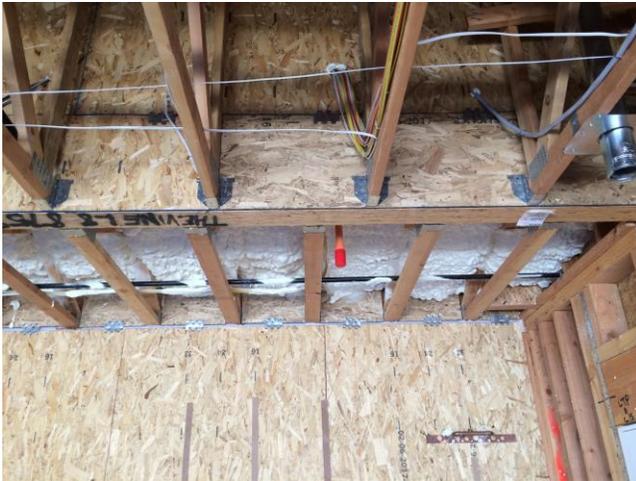
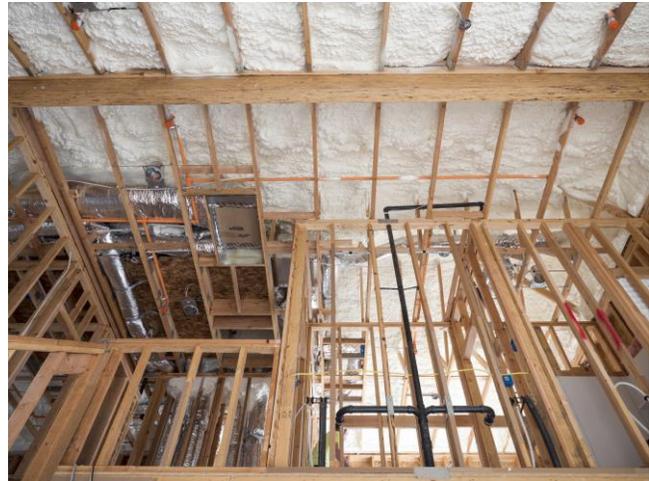
Open-cell spray foam installed at rim joist  
Figure 9. Photos of homes sealed under Option 1

Open-cell spray foam installed below roof deck
